# Manhole Inspection Summary

Manhole # S31AA\_006MH

Insp Date: **12/14/07 1:13 PM**

**Location** Address: **701 SAINT MARY ST**

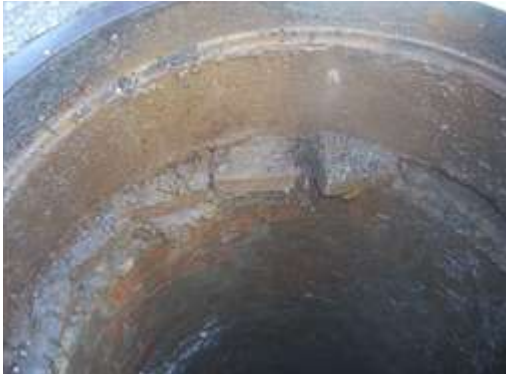
Defect 2

Condition: ☐ Sound ☐ Cracked ☐ Root Intrusion ☒ **Loose Brick** ☒ **Deteriorated**

LOOSE CHIMNEY BRICKS

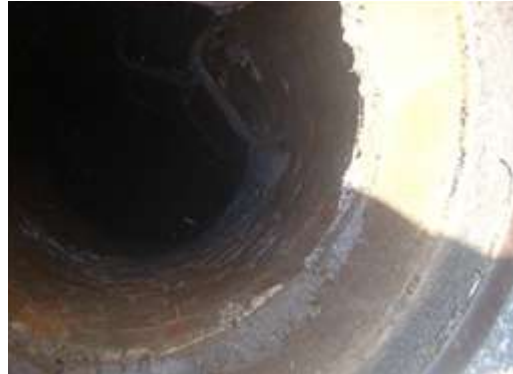
Defect 1

**Steps** Count: **6** Missing: **0** ☒ **Corroded**

FRAME OFFSET AND CORRODED  
STEPS

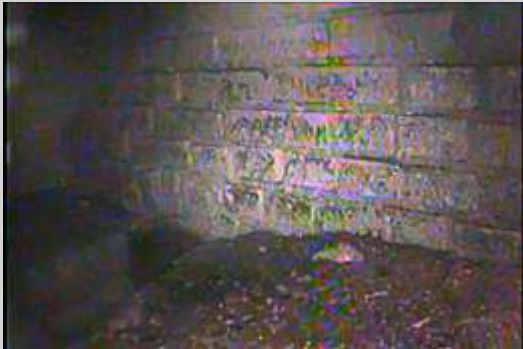
12 O'Clock Outflow

8 in. Circular Gravity Sewer  
Pipe Out @ 12 O'Clock

Pipe Height: **7.2** (in.) Rod and Bar (Angled)  
Pipe Material: **Clay** ☐ Pipe Lined  
Invert Depth: **10.32** (ft.) Flow Characteristics: **Slow**  
Deposits: ☒ None ☐ Mud ☐ Sludge ☐ Debris ☐ Grease  
Silt Depth: (in.) Deposits Extent:  
Infiltration: **None** Pipe Seal Cond: **Sound**

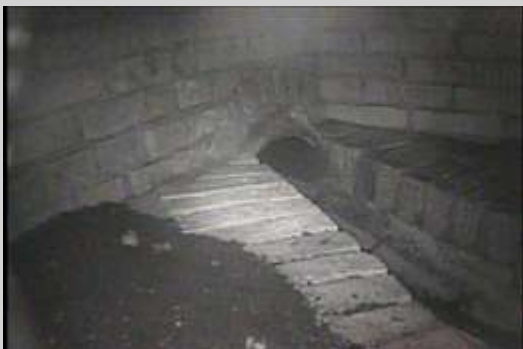
8 O'Clock Inflow

8 in. Circular Gravity Sewer  
Pipe In @ 8 O'Clock

Pipe Height: **8.4** (in.) Rod and Bar (Angled)  
Pipe Material: **Clay** ☐ Pipe Lined  
Invert Depth: **9.74** (ft.) Flow Characteristics: **Slow**  
Deposits: ☒ None ☐ Mud ☐ Sludge ☐ Debris ☐ Grease  
Silt Depth: (in.) Deposits Extent:  
Infiltration: **None** Pipe Seal Cond: **Sound**
